# Low Velocity Car-to-Bus Test Impacts (slightly abridged)

*Written by Robert A. DuBois, Bruce F. McNally, Joseph S. DiGregorio, Gary J. Phillips  
Published: Accident Reconstruction Journal, Vol. 8, No. 5, Sept/Oct 1996*

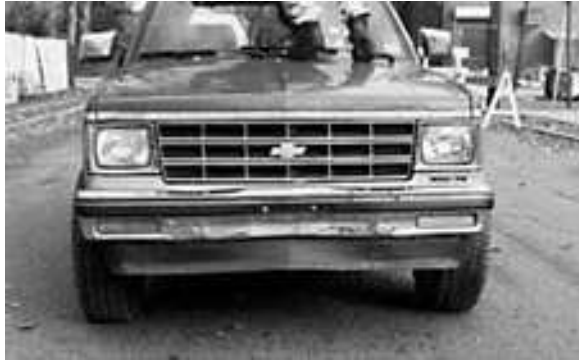
**Figure 1 - Cumulative Damage to Chevy S-10 Blazer After Tests 1-5**

A series of eight impacts using the Chevrolet S-10 Blazer as the striking vehicle were performed. Impact speeds for this vehicle ranged from 1.47 to 7.46 mph. The resulting velocity changes (delta V's) on the bus ranged from a low of 0.18 mph to a high of 1.16 mph. The bus's peak acceleration ranged from 0.26 G's to 1.25 G's. As expected, the S-10's bumper engaged the rear bumper of the target bus. Damage to

the S-10 was confined to the bumper. (See Figure 1.)

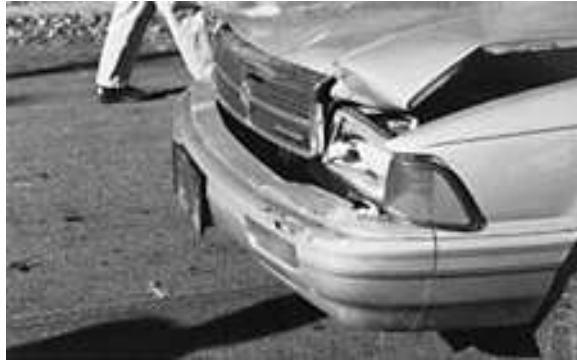
**Figure 2 - Damage to Dodge Spirit After Test 9**

A series of five impacts using the Dodge Spirit as the striking vehicle were performed. Impact speeds for this vehicle ranged from 5.46 to 9.34 mph. The resulting delta V's on the bus ranged from a low of 0.35 to a high of 0.93 mph. The bus's peak acceleration ranged from 0.22 G's to 0.64 G's. Table One shows the data from these tests. As expected, the Spirit's bumper under-rode the rear bumper of the target bus. The bumper of the Spirit was not damaged. Instead, the grille, hood and headlights were crushed. (See Figures 2 and 3.)

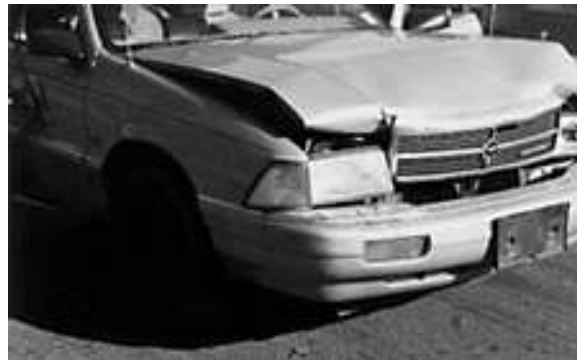
**Figure 3 - Cumulative Damage to Dodge Spirit After Tests 9 & 10**

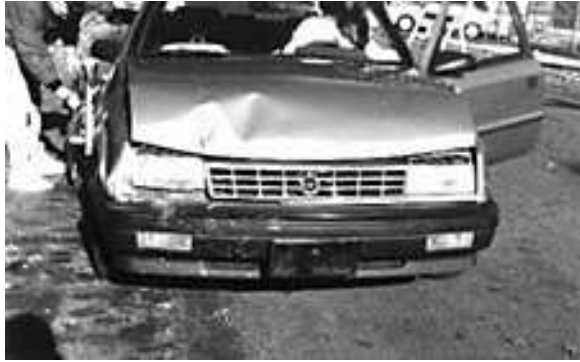
**Figure 4 - Cumulative Damage to Plymouth Sundance After Tests 14 & 15**

A series of five impacts using the Plymouth Sundance as the striking vehicle were performed. Impact speeds for this vehicle ranged from 3.9 to 8.71 mph. The resulting delta V's on the bus ranged from a low of 0.27 mph to a high of 1.19 mph. The bus's peak acceleration ranged from 0.21 G's to 0.90 G's. Table One shows the data from these tests. Like the Dodge, the Plymouth's bumper under-rode the rear bumper of the target bus. Damage was confined to the grille, hood and headlights. (See Figure 4.) In one of these five tests (test #16), the Plymouth struck the bus in an offset manner (nearly a sideswipe) at just over 6 mph. This resulted in the lowest accelerations and delta V's in this series of five tests. Bus post-impact movement was very limited. It ranged from less than an inch to less than 3 inches with the brakes on, and ranged between 6 and 17 inches with the brakes off. Even after all eighteen impacts, there was no measurable damage to the rear bumper of the bus. The only visible damage was small scuffs to the rubber bumper cover. (See Figure 5.)

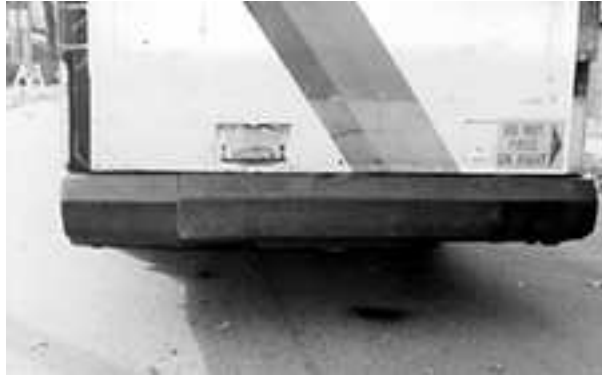
**Figure 5 - Cumulative Damage to Flexible Bus**
